Bridge deck surface damage assessment using point cloud data

ORIGINAL INNOVATION

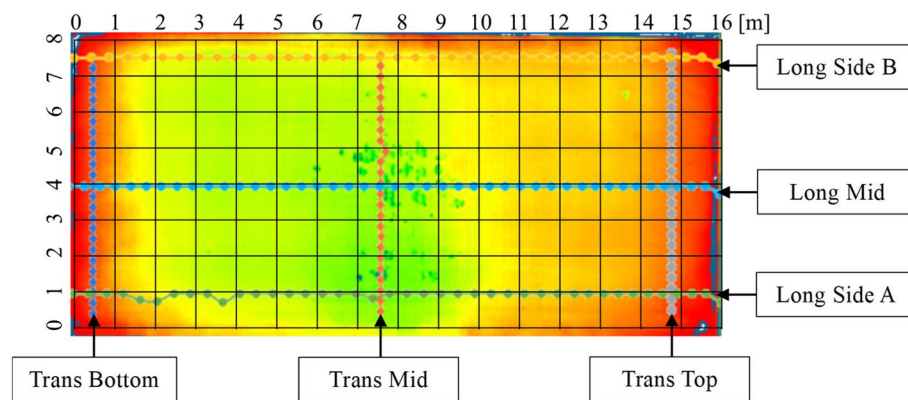
Fig. 3 Plan view of the testbed and location of transverse and longitudinal cross-sections

evaluated in this study. To produce the information presented in Figs. 4 and 5, three longitudinal lines were selected: one near the left edge (“Side B”), one at mid-section, and one near the right edge (“Side A”), and three transverse lines were selected: one near the southern support (“Bottom”), one at mid-span, and one near the northern support (“Top”). The distance between the data points was set to approximately 0.40 m. A plan view of these lines are presented in Fig. 3 to facilitate their reference within the deck.

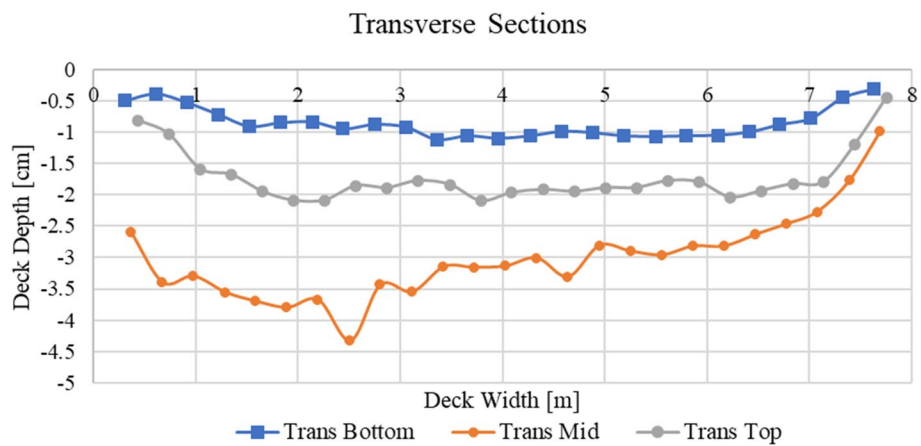
Fig. 5 Deck’s transverse sections

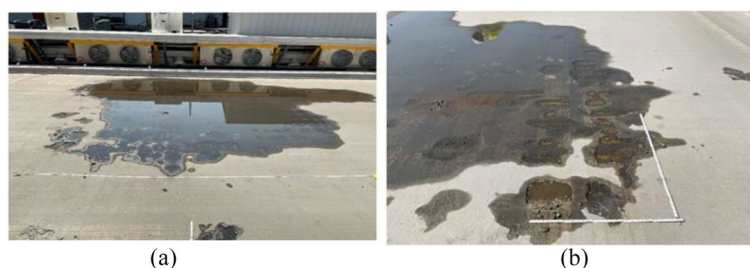
Fig. 8 Visual inspection images from the inspection reports of the testbed (a) Small to large spalls looking east 3,25 m² (35 sq.ft.); (b) large spalls looking south 2,32 m² (25 sq.ft.)

3,25 m² (35 sq.ft.) of damage on the top of the deck of spalls > 2,54 cm (> 1 in.) deep or > 15.24 cm (> 6 in.) in diameter; which from the total area of the deck, equivalent to 111,02 m² (1195 sq.ft.), represent 2.93% of area of damage. The results of the point cloud analysis showed a total of 1,022,188 points identified as damaged points out of the 36,085,551 points in the entire bridge deck’s point cloud, which indicates that the damage represents 2.83% of the bridge d’ck’s total area, or 3,14 m² (33.81 sq.ft.), a 96.6% accuracy when compared to the assessment made through visual inspection. These results suggest that the analysis of the testbed is a reliable method for identifying and quantifying damage on bridge decks. A summary of these results is presented in Table 2.

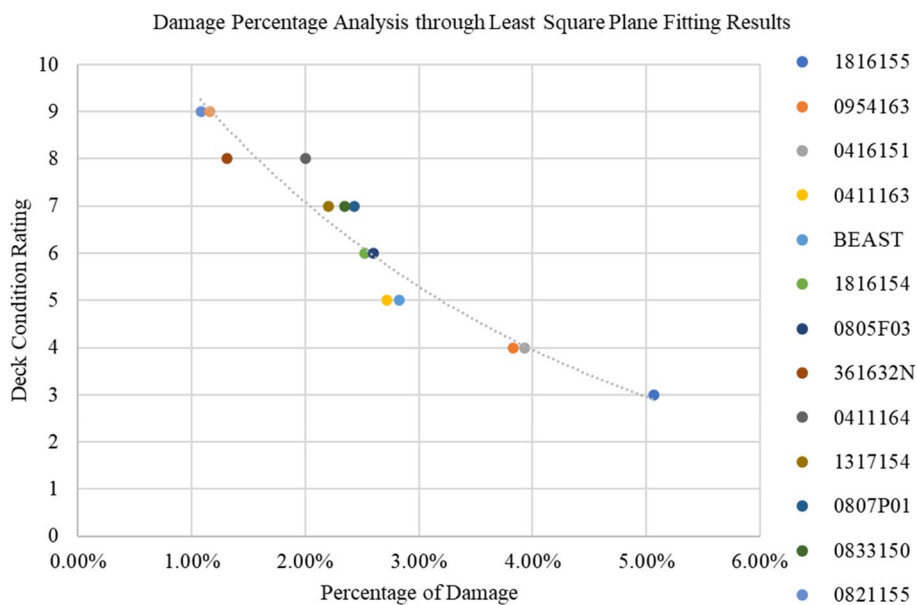
Fig. 10 Condition rating vs. Percent of Damaged

The trend found in Fig. 10 evidences a correlation between the deck’s condition rating and the level of damage found on the top surface. This graph includes the thirteen bridge decks from NJ and the testbed from the BEAST Laboratory.
