Case Report: Holmium Laser Removal of Antegrade Ureteral Stent Suture via Ureteroscopy

Paul Chialastri DO, MS¹; Jerome Pietras DO^{2;} Thomas Mueller MD² ¹RowanSOM, Stratford NJ; ²New Jersey Urology, Voorhees NJ

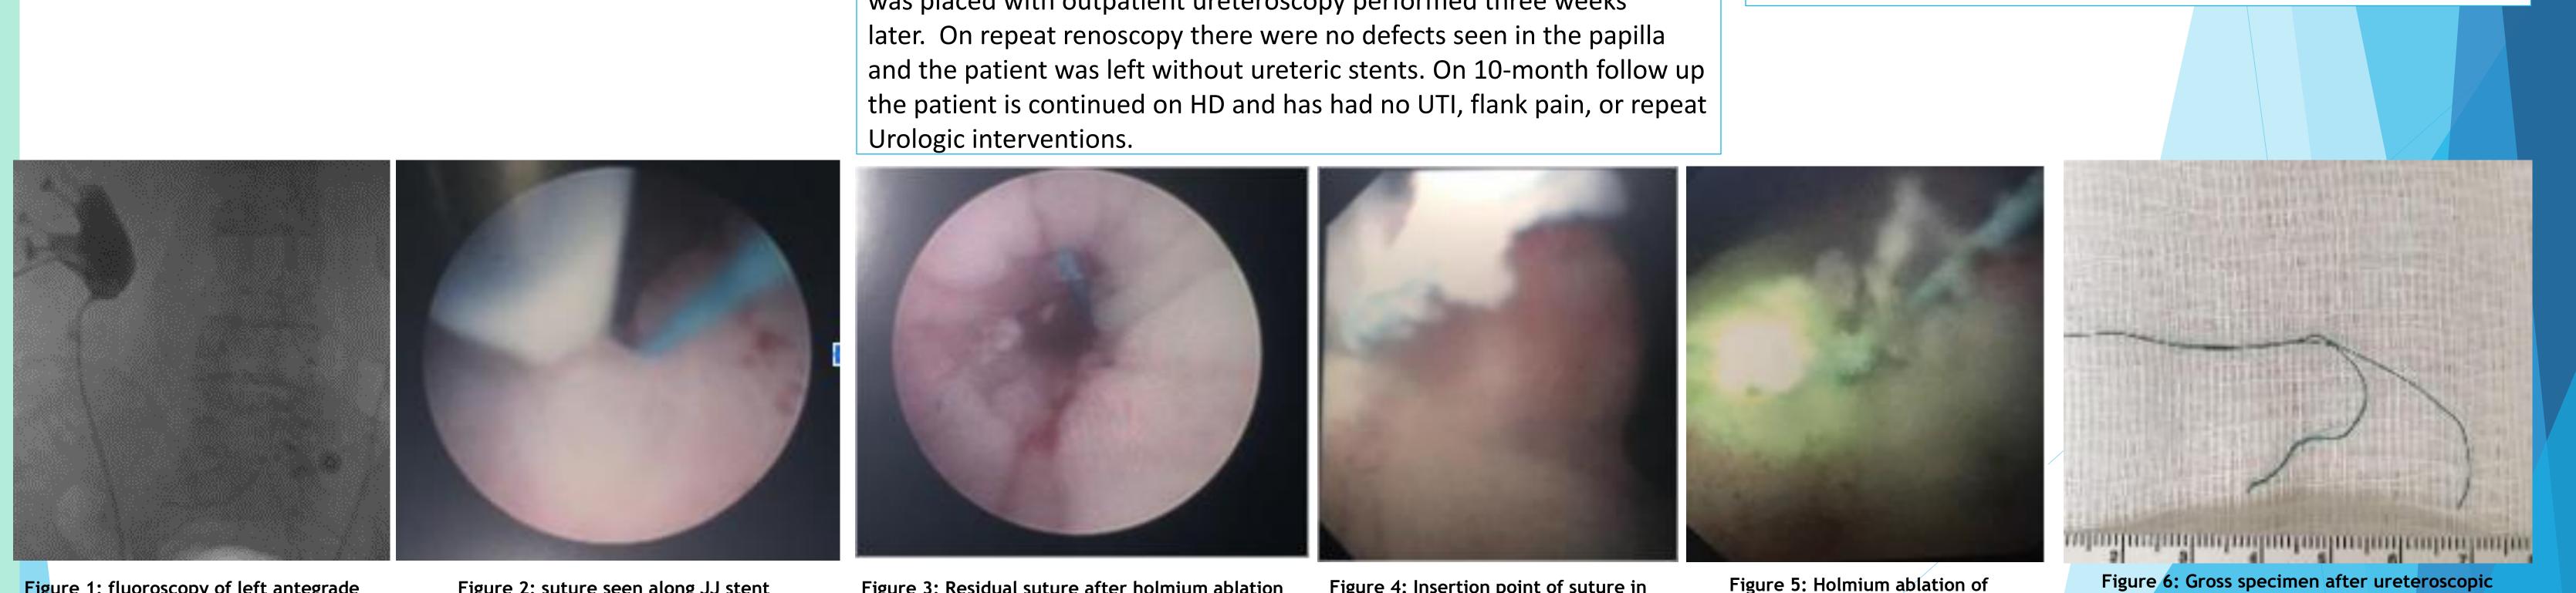
Figure 1: fluoroscopy of left antegrade JJ stent placement

Figure 2: suture seen along JJ stent

Figure 3: Residual suture after holmium ablation and JJ stent removal

Figure 4: Insertion point of suture in lower pole papilla

Figure 5: Holmium ablation of residual suture at lower pole papilla extraction

At our institution we commonly enlist Interventional Radiology for internalization of percutaneous nephrostomy tubes to JJ stents. This likely represents an unreported retained suture from the internalized stent that has ingrown into the renal parenchyma. There was no reported difficulty in placement per the procedural note and no skin defect. The incidence of this occurring is unknown and no similar case reports could be found on literature review. The string was unable to be pulled with graspers but laser ablation of the string appeared to remove all components in the collecting system despite likely leaving behind a short segment in the renal parenchyma.

Retained suture from an antegrade ureteric stent appears to be a rare phenomenon preventing simple cystoscopic stent removal. Ureteroscopy with holmium lasering of retained suture appears safe for removal of retained stents with suture left in the renal parenchyma with no visible defect seen on follow-up renoscopy.
